## How to make Stone Masonry Buildings Earthquake Resistant?

### Behaviour during Past India Earthquakes

### Earthquake Resistant Features

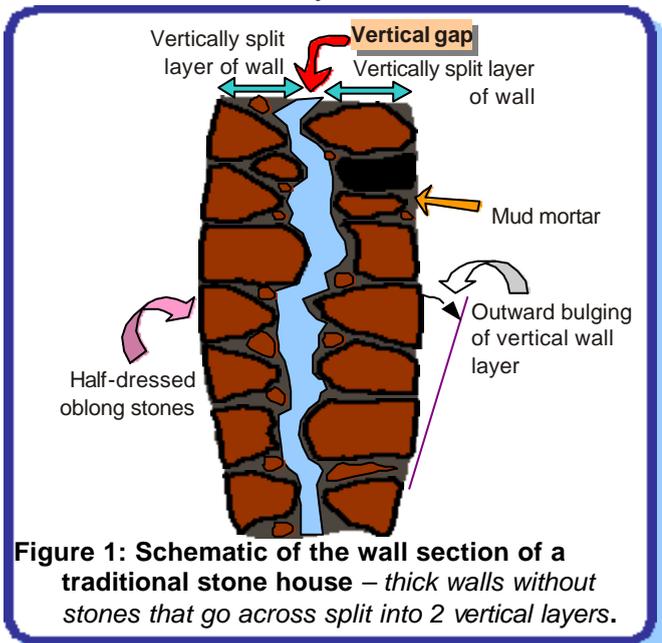
Stone has been used in building construction in India since ancient times since it is durable and locally available. There are huge numbers of stone buildings in the country, ranging from rural houses to royal palaces and temples. In a typical rural stone house, there are thick stone masonry walls (thickness ranges from 600 to 1200 mm) built using rounded stones from riverbeds bound with mud mortar. These walls are constructed with stones placed in a random manner, and hence do not have the usual layers (or *courses*) seen in brick walls. These uncoursed walls have two exterior vertical layers (called *wythes*) of large stones, filled in between with loose stone rubble and mud mortar. A typical *uncoursed random (UCR)* stone masonry wall is illustrated in Figure 1. In many cases, these walls support heavy roofs (for example, timber roof with thick mud overlay).

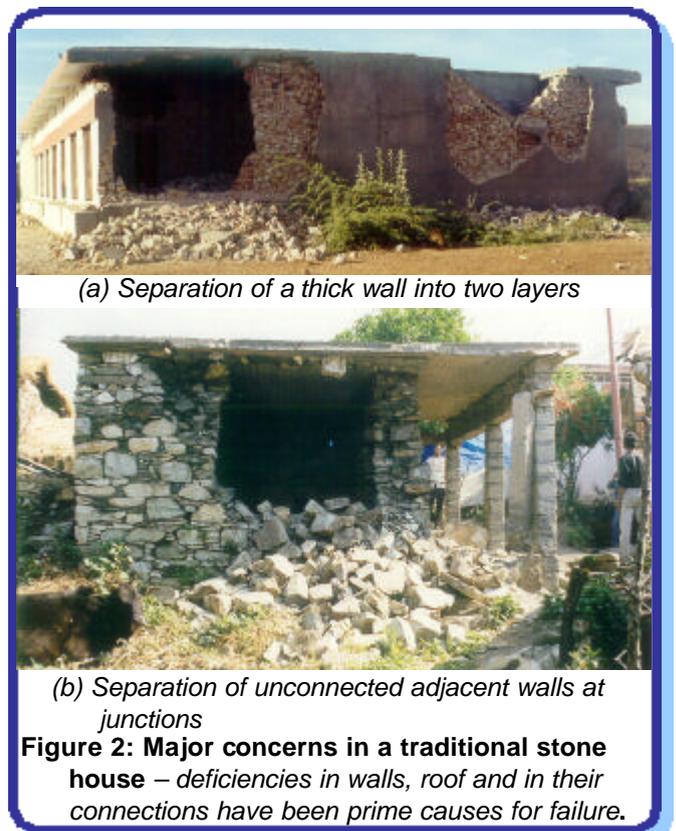
The main patterns of earthquake damage include: (a) bulging/separation of walls in the horizontal direction into two distinct *wythes* (Figure 2a), (b) separation of walls at corners and T-junctions (Figure 2b), (c) separation of poorly constructed roof from walls, and eventual collapse of roof, and (d) disintegration of walls and eventual collapse of the whole dwelling.

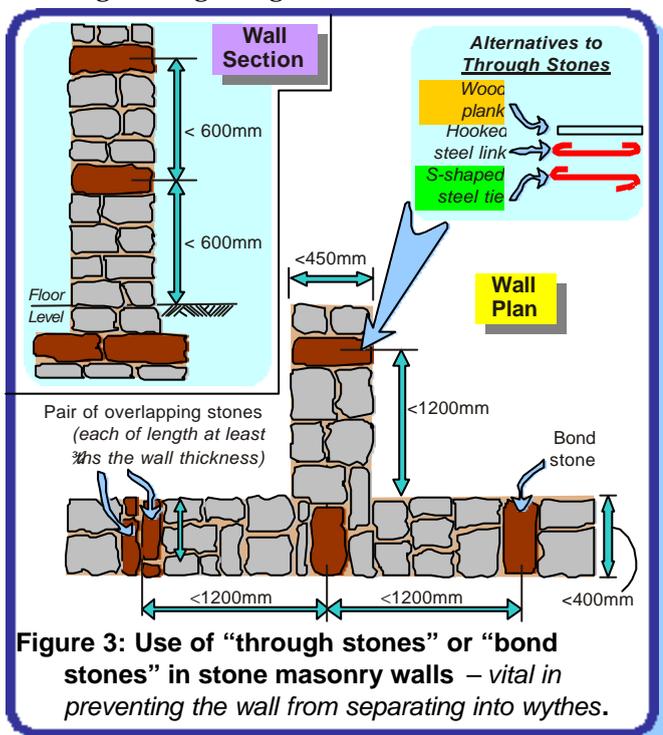
**Figure 3: Use of “through stones” or “bond stones” in stone masonry walls – vital in preventing the wall from separating into wythes.**

- (a) *Ensure proper wall construction* The wall thickness should not exceed 450mm. Round stone boulders should not be used in the construction! Instead, the stones should be shaped using chisels and hammers. Use of mud mortar should be avoided in higher seismic zones. Instead, cement-sand mortar should be 1:6 (or richer) and lime-sand mortar 1:3 (or richer) should be used.
- (b) *Ensure proper bond in masonry courses*: The masonry walls should be built in construction lifts not exceeding 600mm. *Through-stones* (each extending over full thickness of wall) or a pair of overlapping *bond-stones* (each extending over at least  $\frac{3}{4}$ th thickness of wall) must be used at every 600mm along the height and at a maximum spacing of 1.2m along the length (Figure 3).

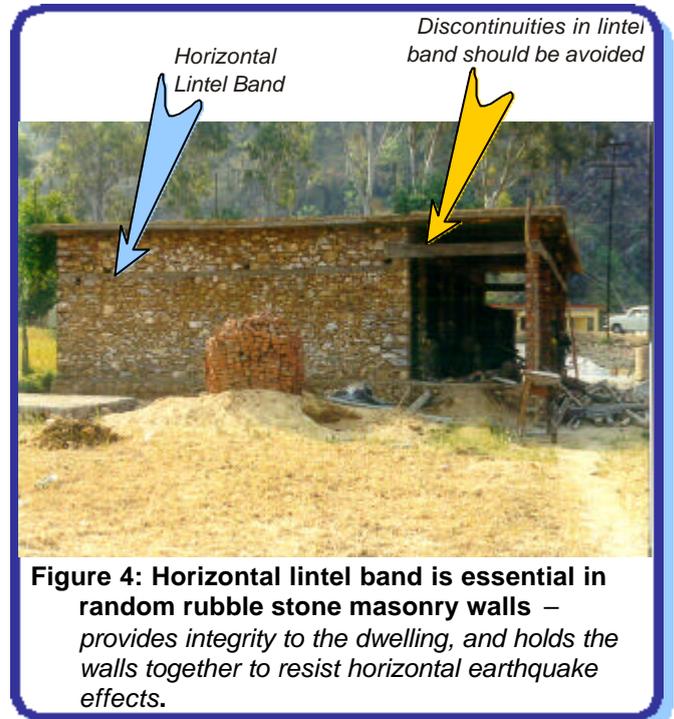
**Figure 4: Horizontal lintel band is essential in random rubble stone masonry walls – provides integrity to the dwelling, and holds the walls together to resist horizontal earthquake effects.**

- (c) *Provide horizontal reinforcing elements*: The stone masonry dwellings must have horizontal bands (See IITK-BMTPC Earthquake Tip 14 for *plinth, lintel, roof* and *gable bands*). These bands can be constructed out of wood or reinforced concrete, and chosen based on economy. It is important to provide at least one band (either *lintel band* or *roof band*) in stone masonry construction (Figure 4).
